THE FIELD ESTIMATION OF SHEAR STRENGTH ON ROCK  
DISCONTINUITIES

SUBMITTED TO THE FACULTY OF GRADUATE STUDIES AND RESEARCH  
IN PARTIAL FULFILMENT OF THE REQUIREMENTS FOR THE DEGREE  
OF DOCTOR OF PHILOSOPHY

CIVIL ENGINEERING

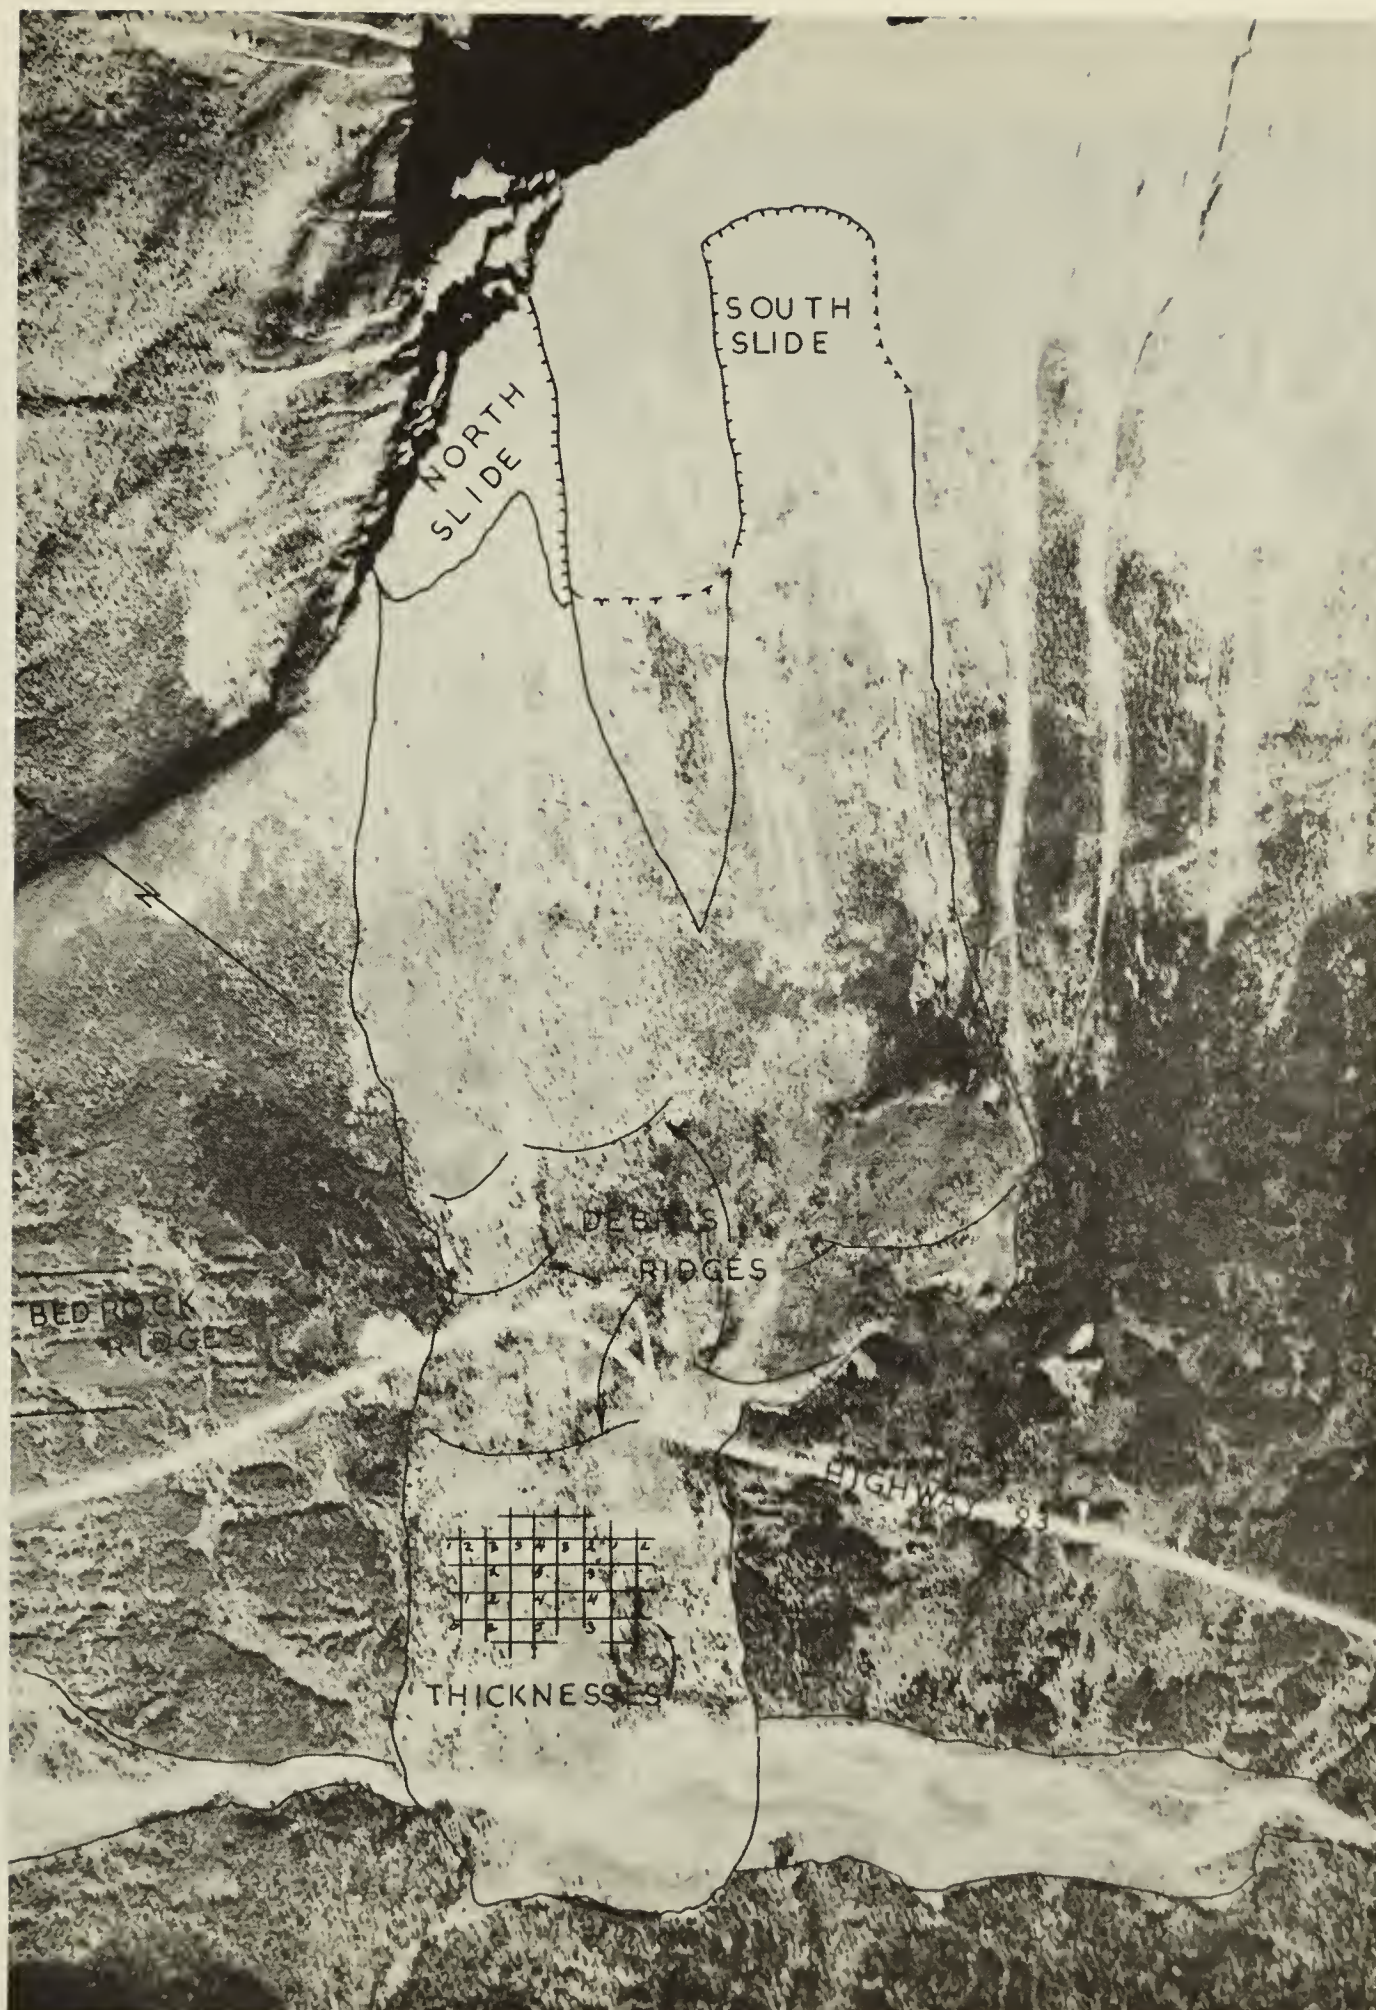
PLATE 2-1 Air Photo Of The Jonas Creek Slide Area Showing  
Debris Outlines And Thicknesses.

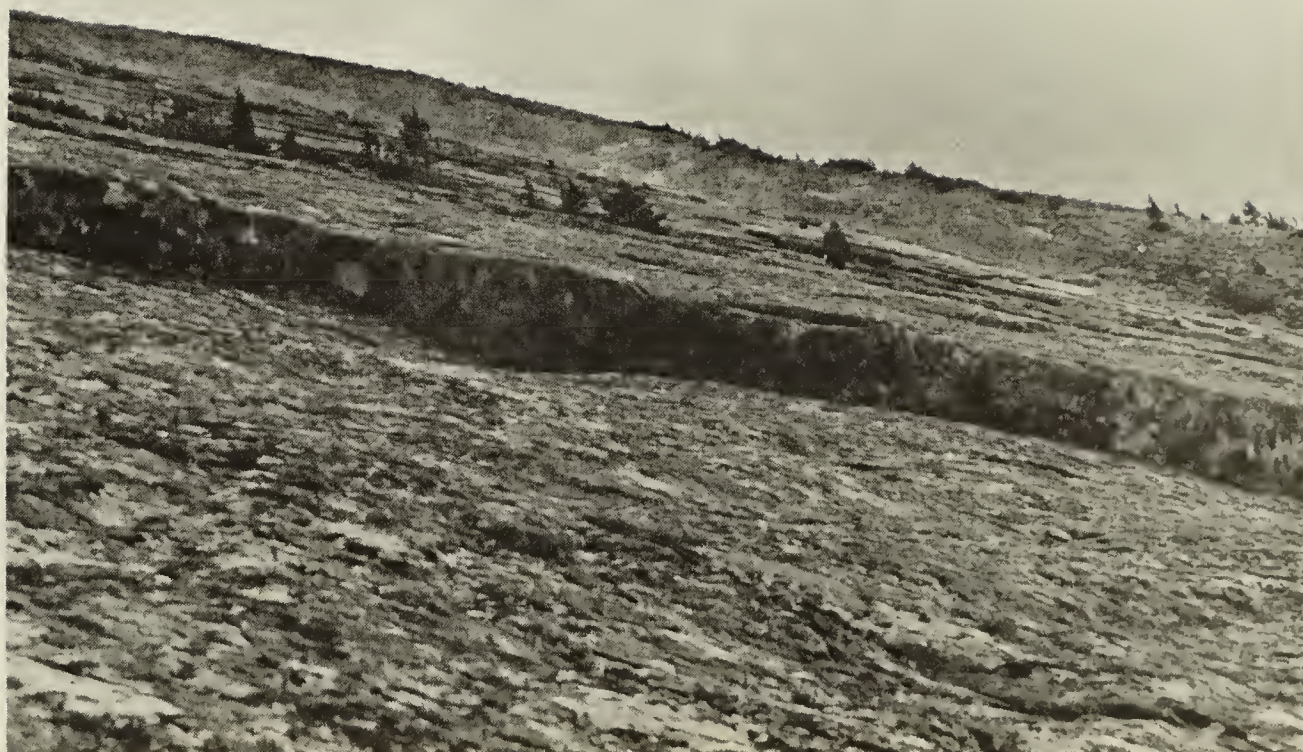
PLATE 2-3    Photograph Of The Failure Surface At Jonas Creek  
Showing Large Scale Cross Bedding.

Plate 2-3 is a photograph of large scale cross-bedding observed on the slope at Jonas Creek. The cross-bedding dip at Jonas Creek was parallel to the rock slide failure

direction and thus may have contributed significantly to the down dip roughness angle acting on the failure surface. Further discussions with respect to the variations in roughness are detailed in Chapter 4.

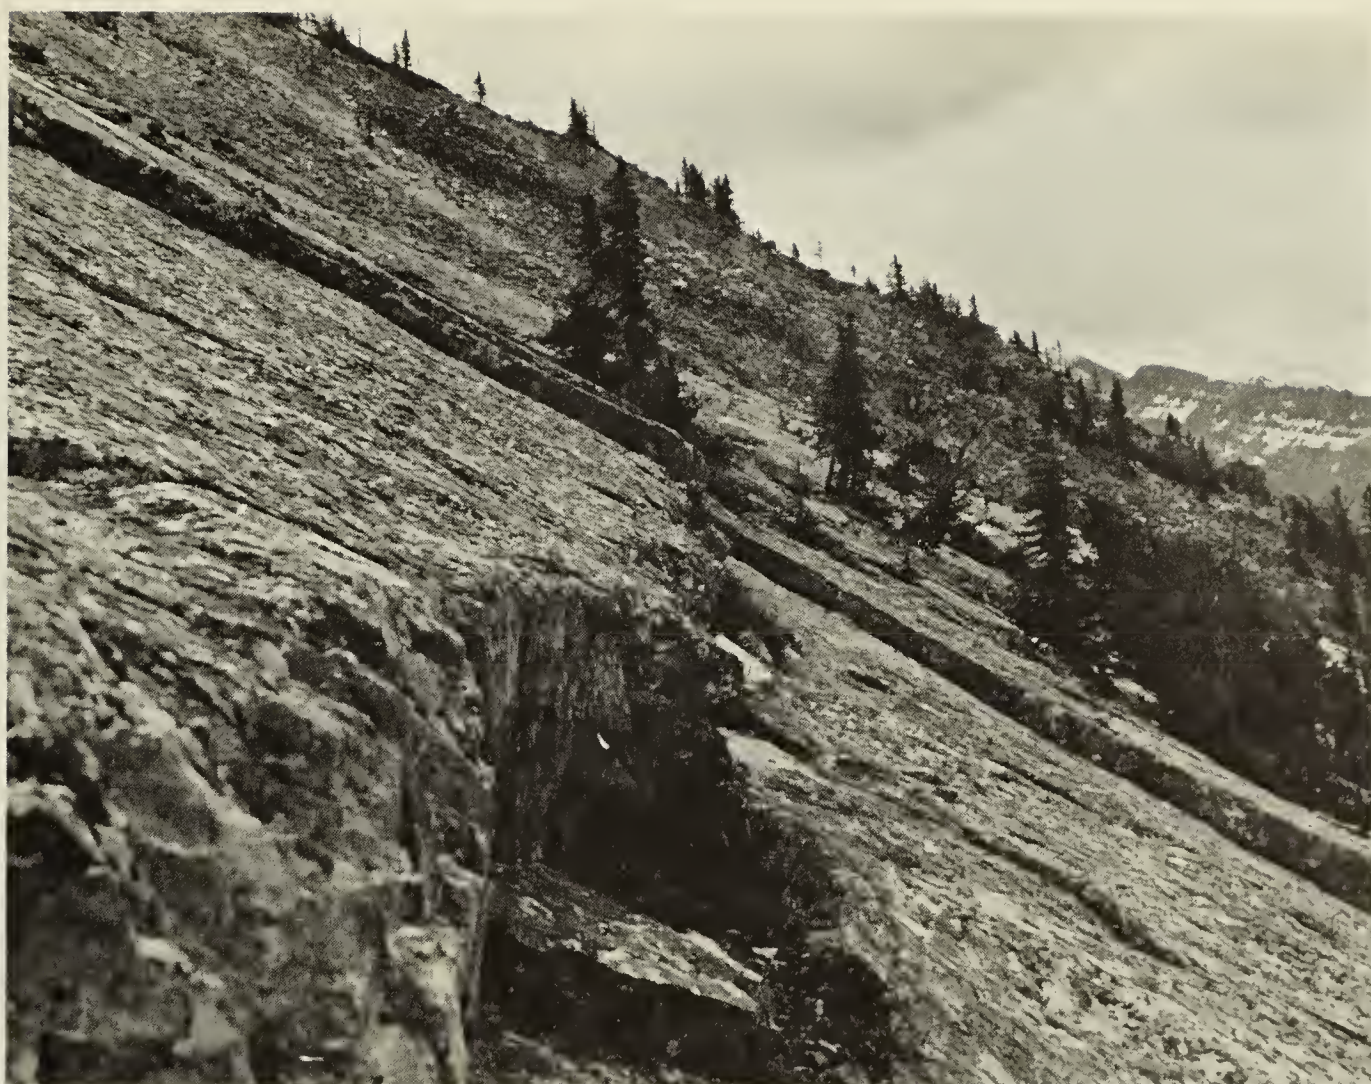
PLATE 2-4 Photograph Of The North Failure Plane  
Showing The Vertical Joints Which  
Occurred Between Beds.

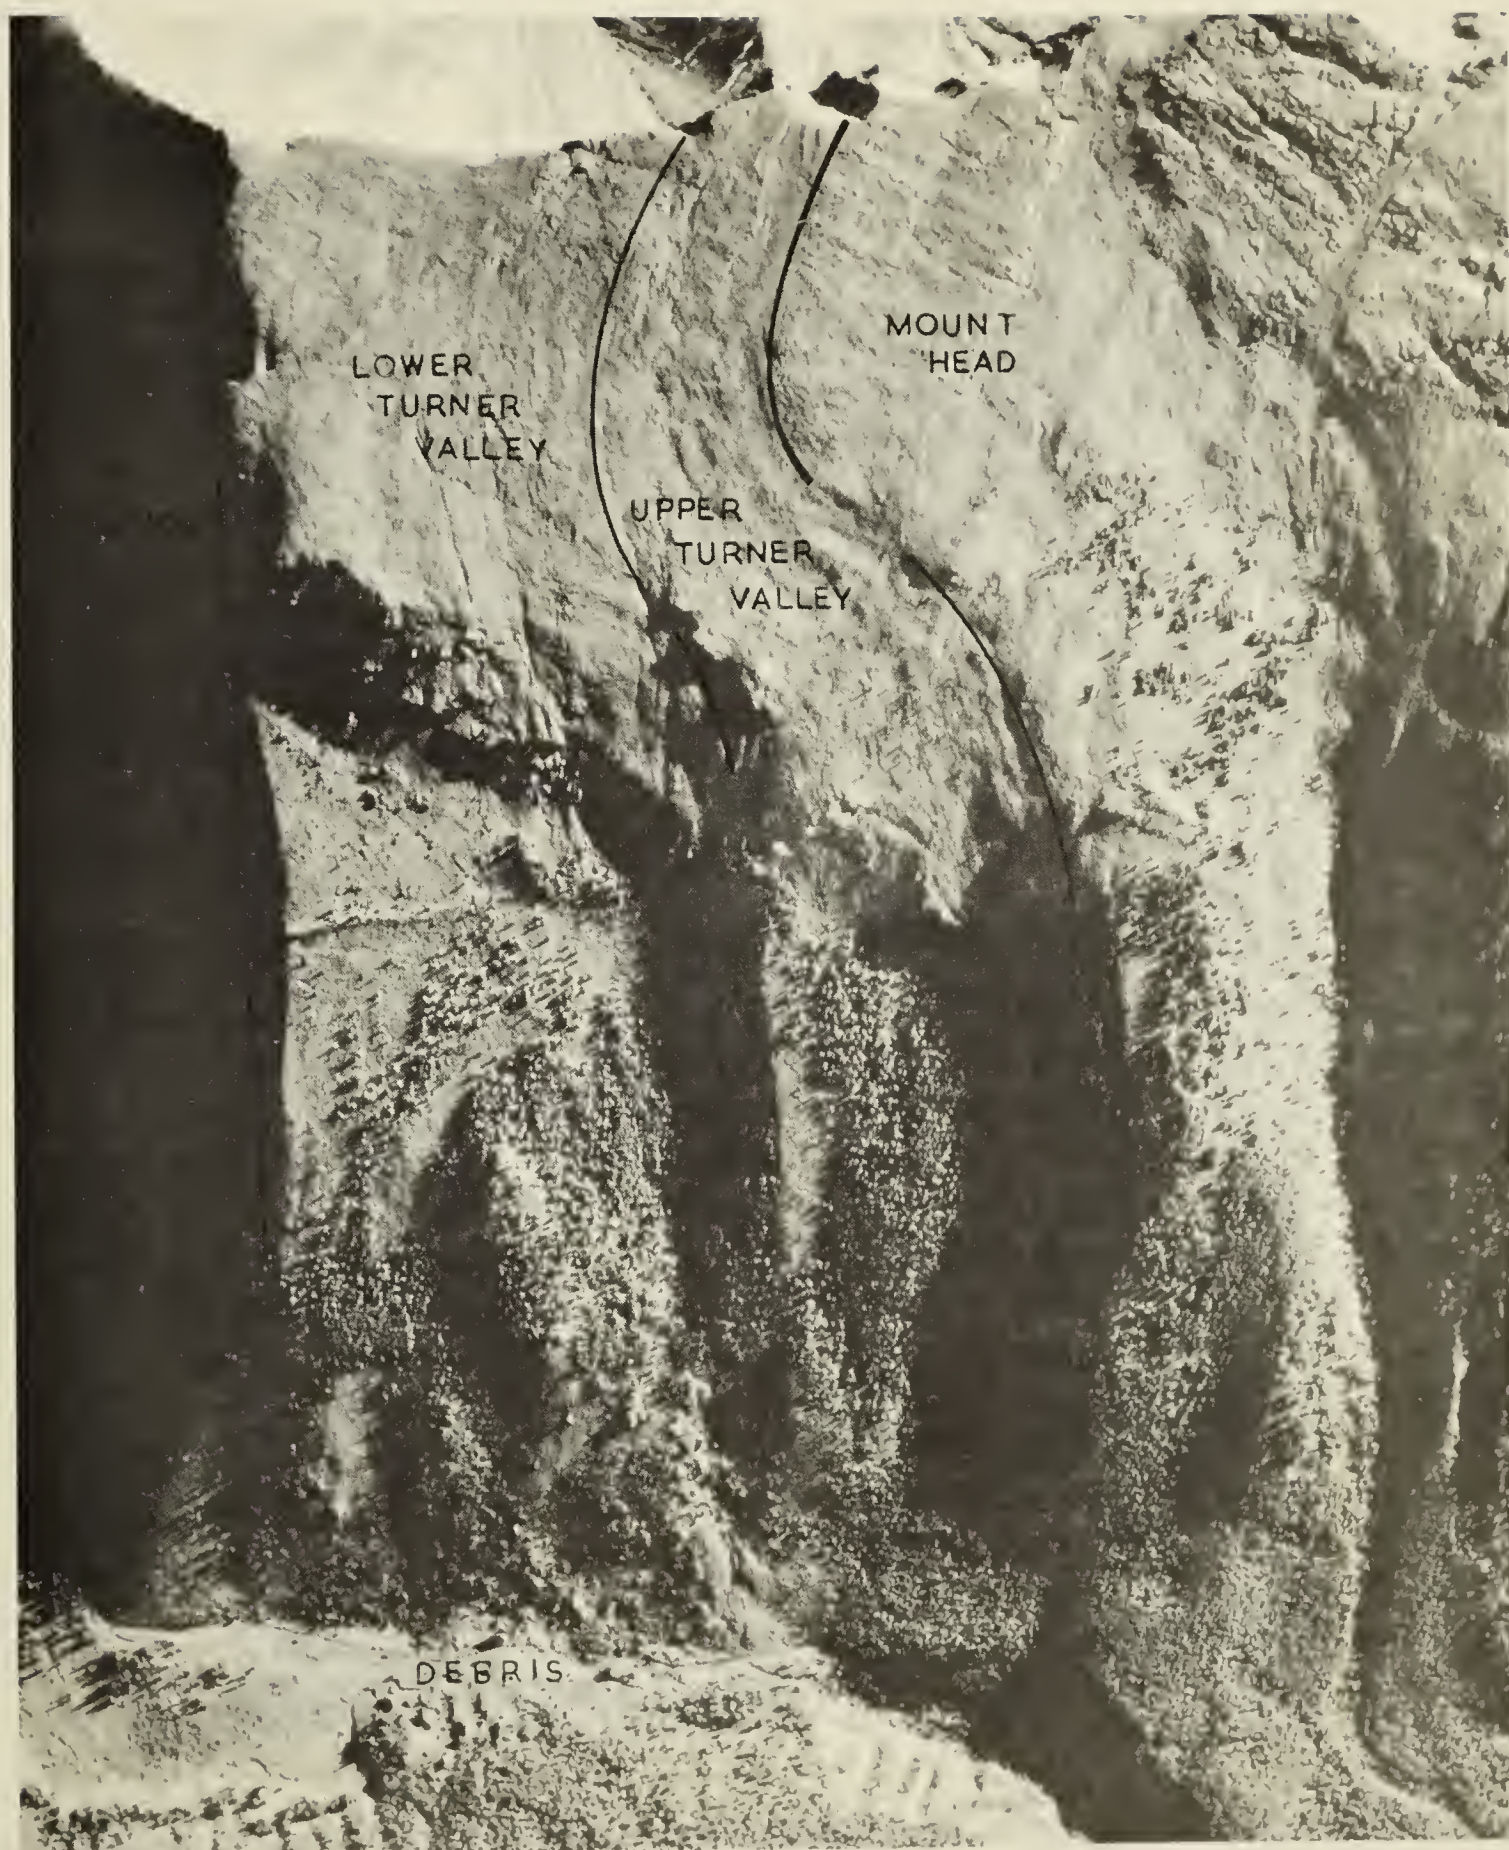
plate 3-2 Bedrock Geology Shown Overlain On An AirPhoto  
Of The Slides At Whitehorse Creek.

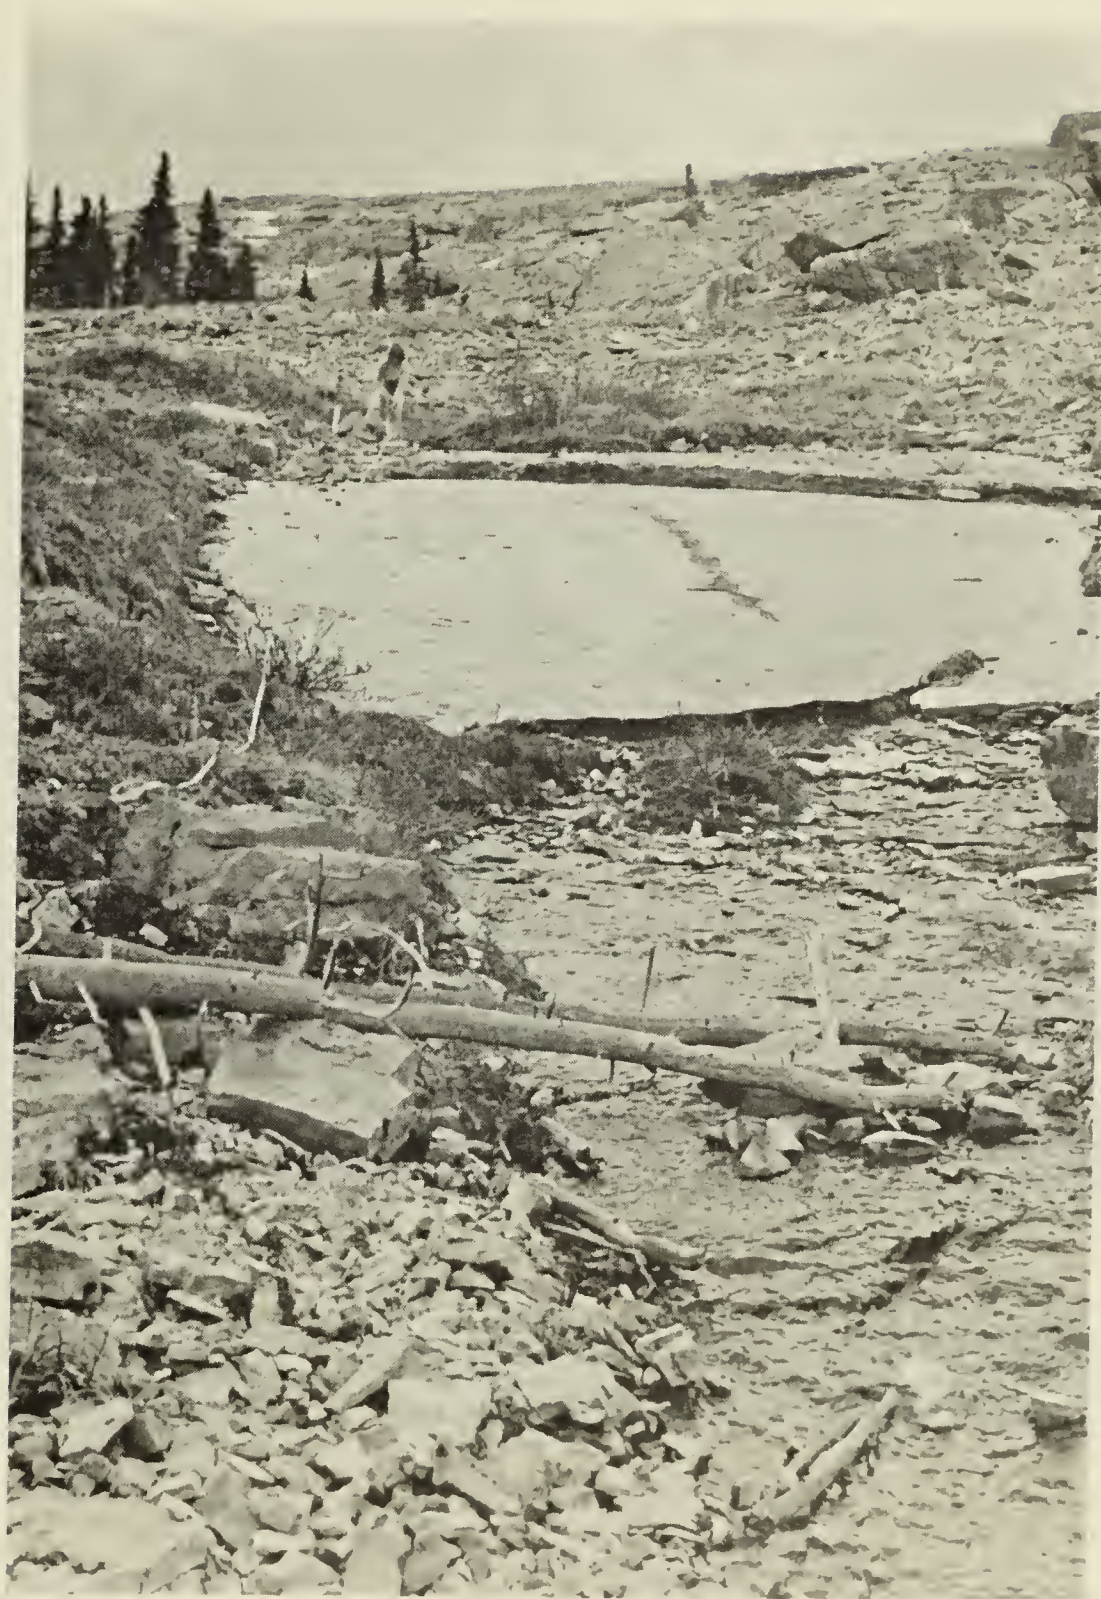
PLATE 3-3 Photograph Of Part Of The Failure Surface At Whitehorse  
Creek Showing Small Vertical Steps.

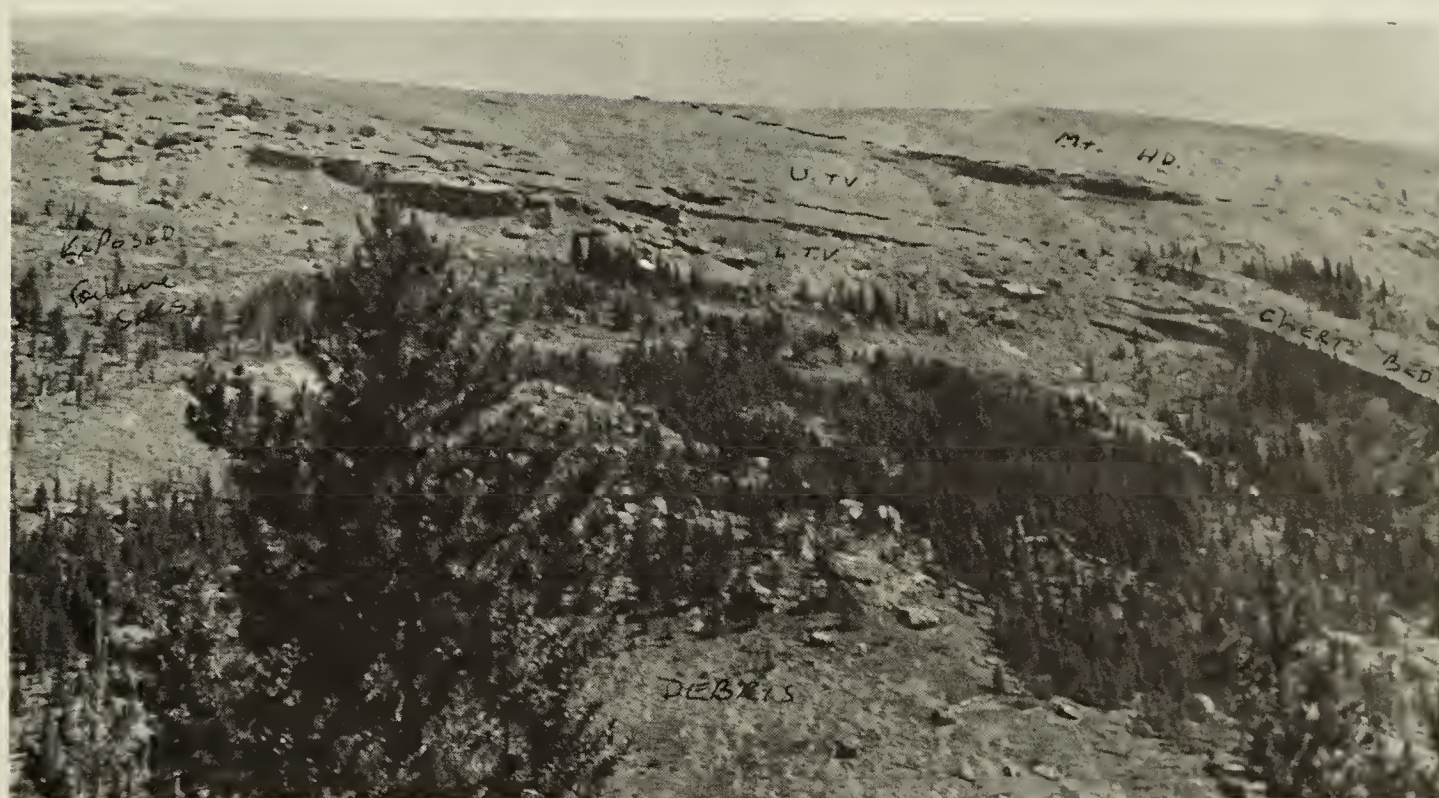
PLATE 3-4 Photo Of The Scarp At Whitehorse Creek Showing  
Vertical Joints Forming Back And Side Scarps.

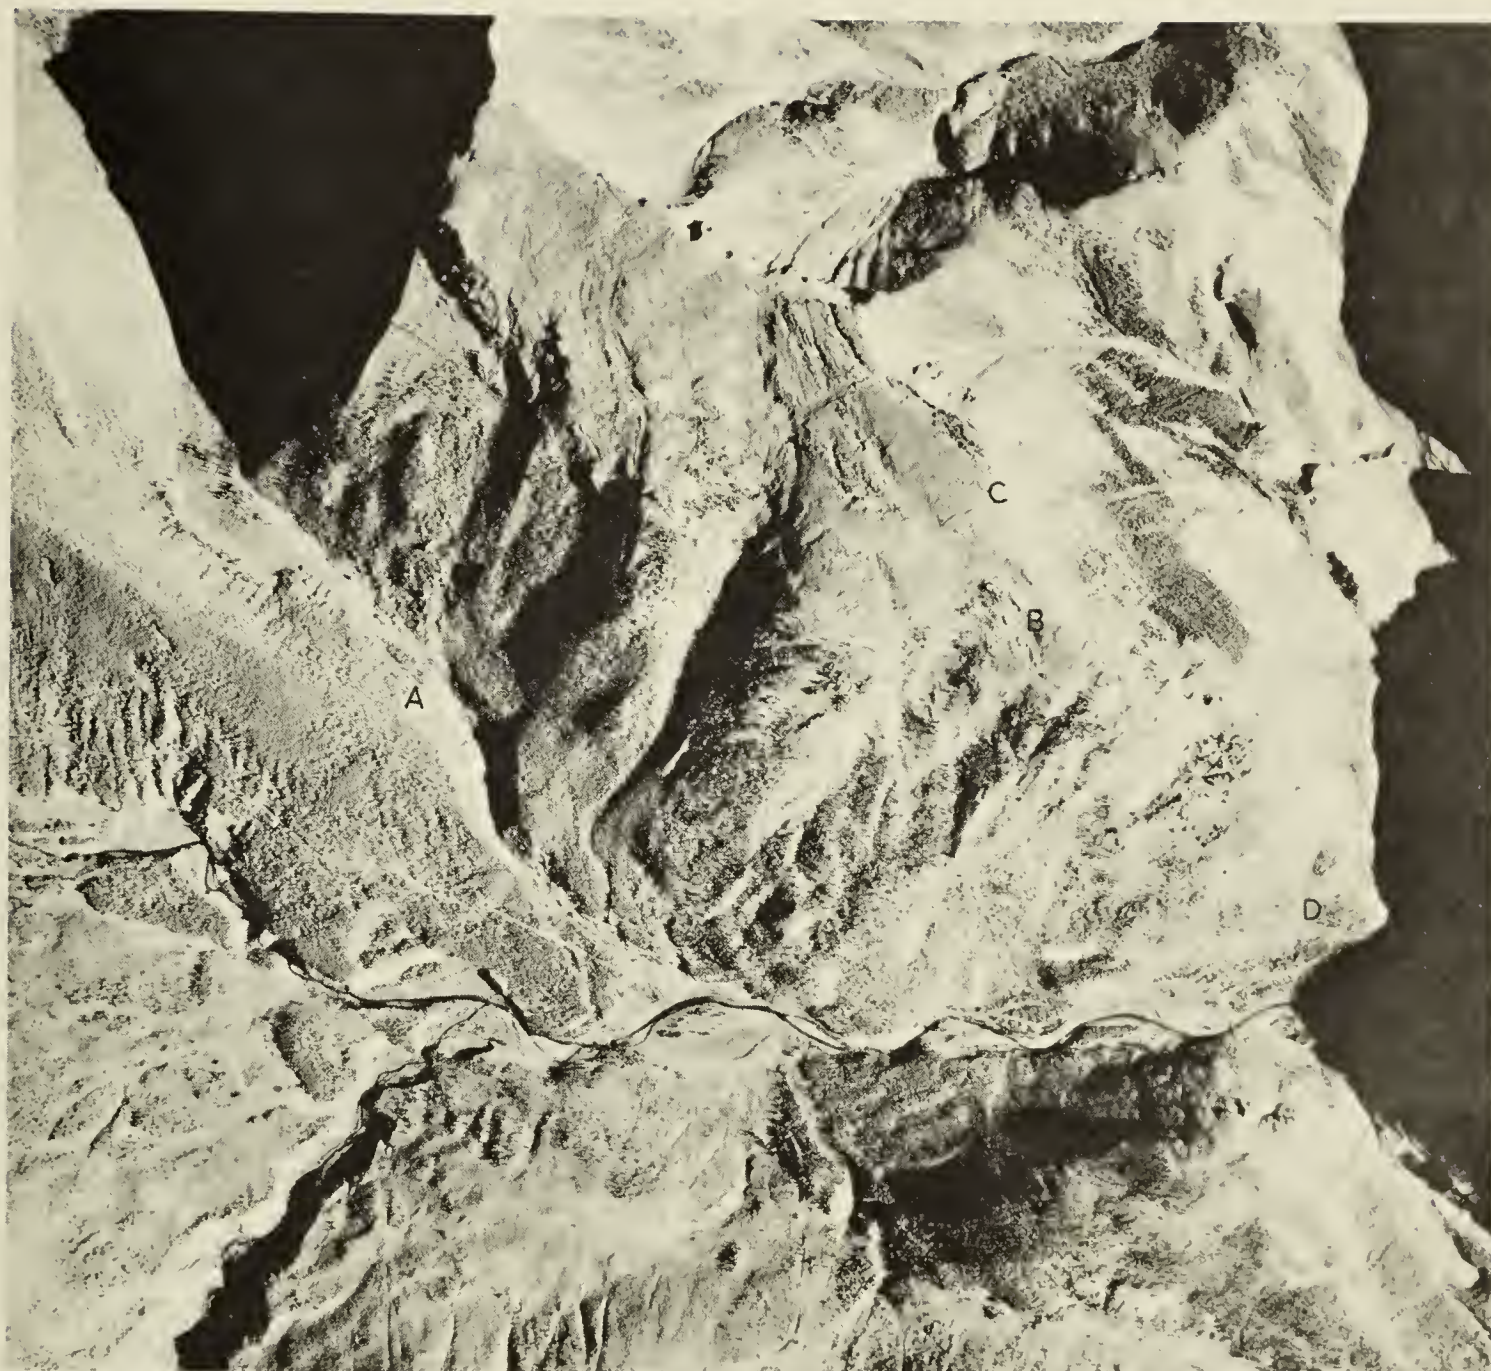
PLATE 3-5    Air Photo of The The Entire Ridge At Whitehorse Creek.  
Note   The Point A Where The Small Creek Changes  
Direction, Boulders At B, And Cracks At C.
